Case Study –Ancient, Veteran Beech Trees; Blenheim Palace, Woodstock, Oxfordshire. Inspected July 2007.

Thermal Imaging Survey

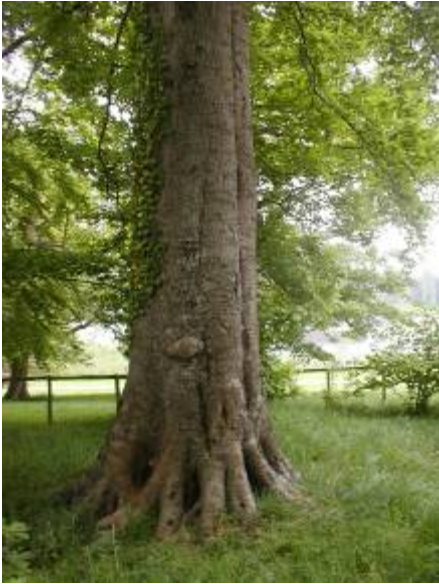
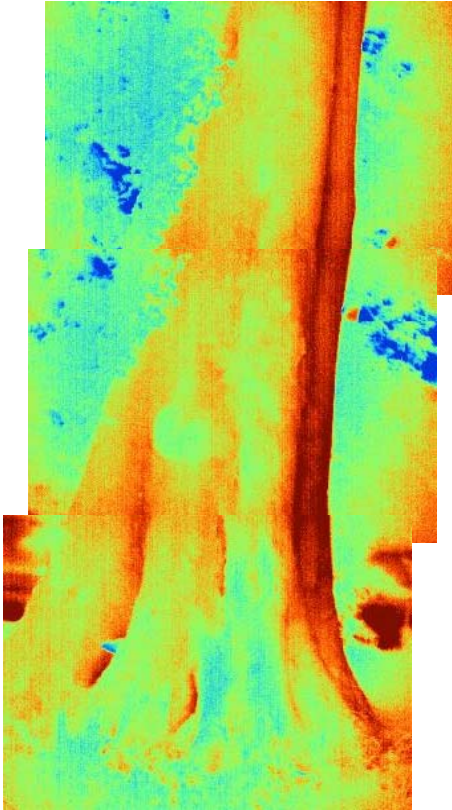
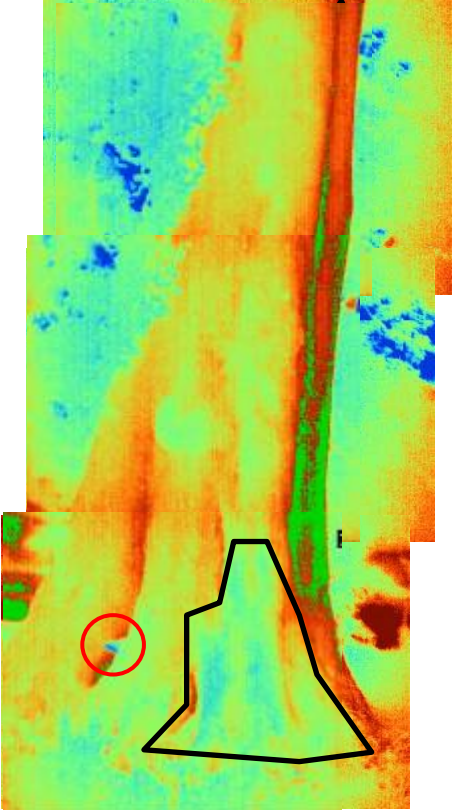
Visual Image	Thermal Image	Annotated Image	Annotation Details

<p>Data Sheet: Tree 4 Date: 03/05/07 Client: Paul Orsi, Blenheim Palace Tree No.: 4 TAG No.: 503 Species: <i>Fagus sylvatica</i> Location: Above Seven Arches Position: Bank away from road side. Direction Images Taken: 186°</p>	<p>Summary of inspection details: There are areas of superheating associated with decay probably from <i>Ganoderma spp</i> (fruiting bodies apparent, see inset photo)there is an area of thin buttresses (blue areas at base) but also vigorous growth in the base of the tree (orange colours). Outcomes: There is 70-80% dysfunction in the base and it is highly probable most of this relates to <i>Ganoderma spp</i> related decay although the decay is not concentric being closer to the surface of some buttresses rather than others. The tree is a high probability of failure in its present state. An invasive inspection should be carried out.</p>
---	--

<p>Green coloured areas indicate areas of decay close to the surface (superheated).. The black enclosed area (blue-green) indicates buttresses over a large volume of dysfunctional wood, weak buttresses. Other buttresses are associated with thicker volumes of functional wood. A fruiting body of <i>Ganoderma spp</i> is circled red.</p>

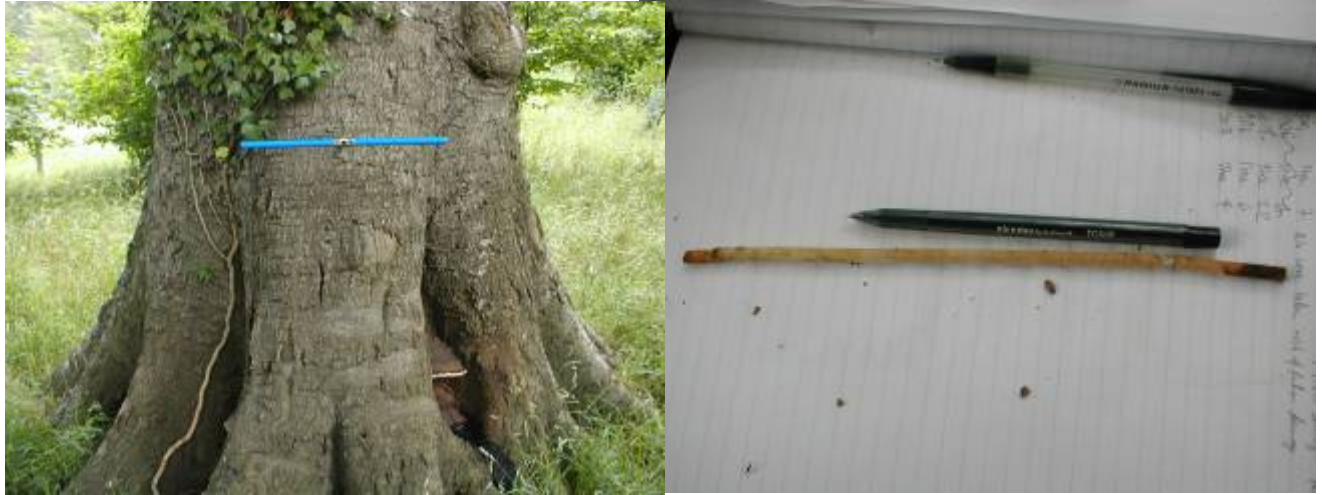
Outcomes Tree 4.

Core taken from the thickest part of the sound wood showing 16 cm of sound wood around 40 % of the radius. Around 74% of the wood is decayed at this height. The tree is currently sheltered and can be retained as it is followed by re-inspection 12 months.

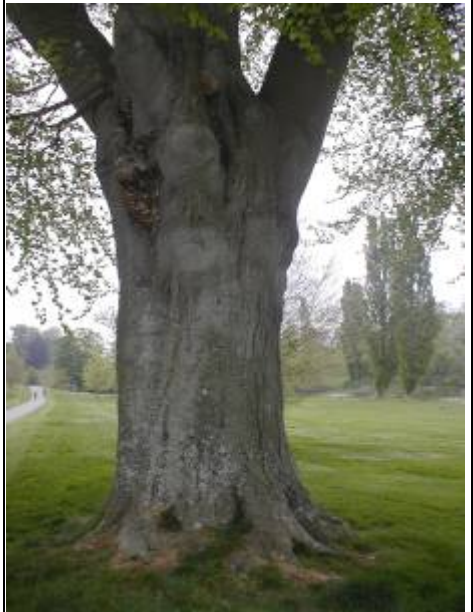
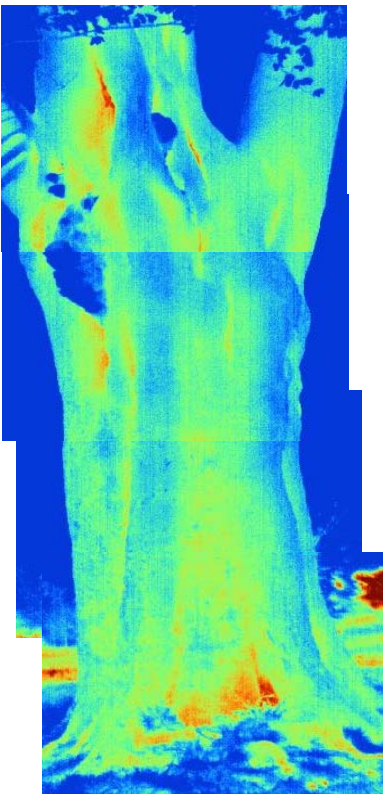
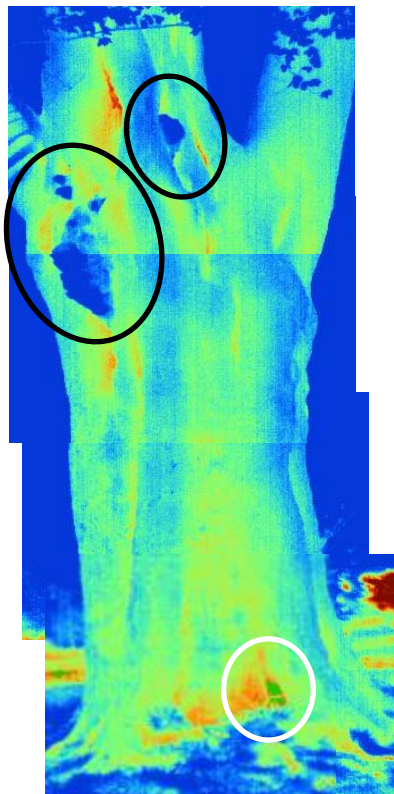
Visual Image	Thermal Image	Annotated Image	Annotation Details

<p>Data Sheet: Tree 6-1 Date: 03/05/07 Client: Paul Orsi, Blenheim Palace Tree No.: 6 TAG No.: 906 Species: <i>Fagus Sylvatica</i> Location: GB > Fisheries Position: Close to road Direction Images Taken: 32°</p>	<p>Summary of inspection details: There are distinct areas of superheating indicating areas of decay close to the surface. The cooler areas indicate large volumes of dysfunction but the warmer areas indicate this is not concentric with thicker areas of functional wood present. The two larger blue areas denote the presence of fruiting bodies. Outcomes: The tree has 70-80 %dysfunction in the base that progresses up the main stem and into the branching points. There is a high-severe probability of failure at the base and a high probability in the branches. An invasive inspection should be carried out at the base.</p>
---	--

<p>Circled areas (blue) indicate the location of fruiting bodies. There are volumes of wood with good functionality (orange-yellow) but these are thin in some parts (blue areas). There is a small area of decayed wood at the base (superheated area coloured green, circled white).</p>

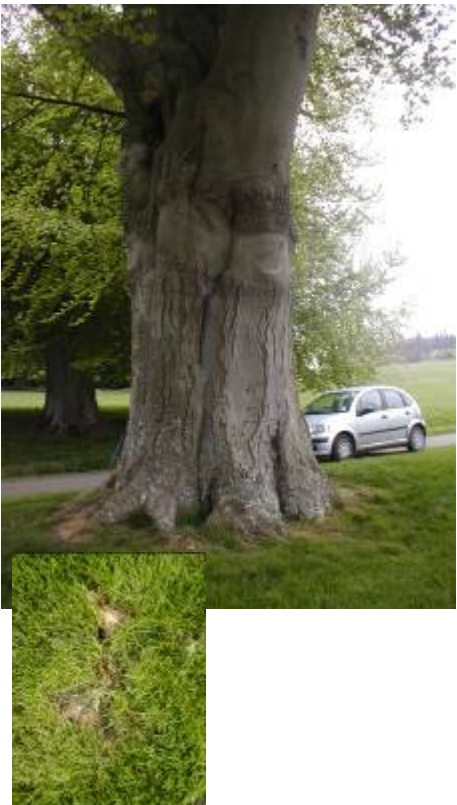
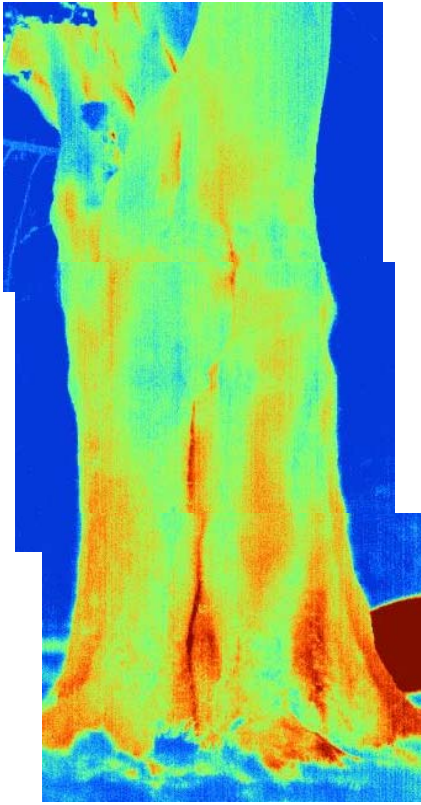
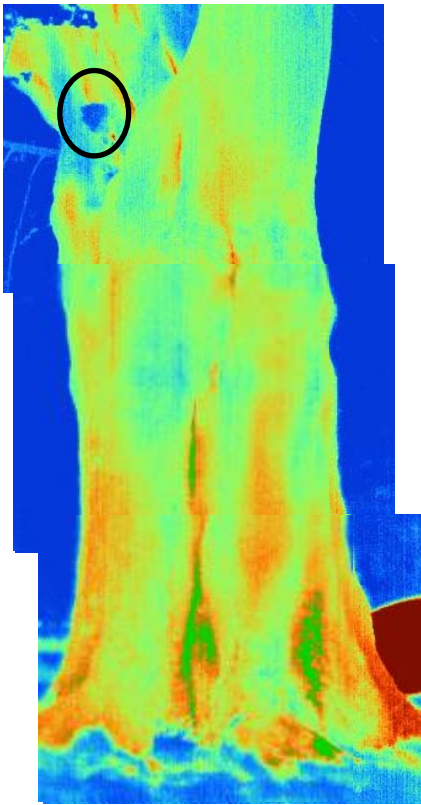
Visual Image	Thermal Image	Annotated Image	Annotation Details

<p>Data Sheet: Tree6-2 Date: 03/05/07 Client: Paul Orsi, Blenheim Palace Tree No.: 6 TAG No.: 906 Species: <i>Fagus Sylvatica</i> Location: GB > Fisheries Position: Direction Images Taken: 313°</p>	<p>Summary of inspection details: There are distinct areas of superheating indicating areas of decay close to the surface. The cooler areas indicate large volumes of dysfunction but the warmer areas indicate this is not concentric with thicker areas of functional wood present. The small blue area denotes the presence of fruiting body. In addition the remains of another unidentified fruiting body was found in the grass close to the tree (see photo inset). Outcomes: Refer to the previous sheet.</p>
---	--

<p>The green coloured areas indicate areas of decay close to the surface (superheated). There are volumes of wood with good functionality up the main-stem and extending into the branches indicated by the red-orange colours.</p>

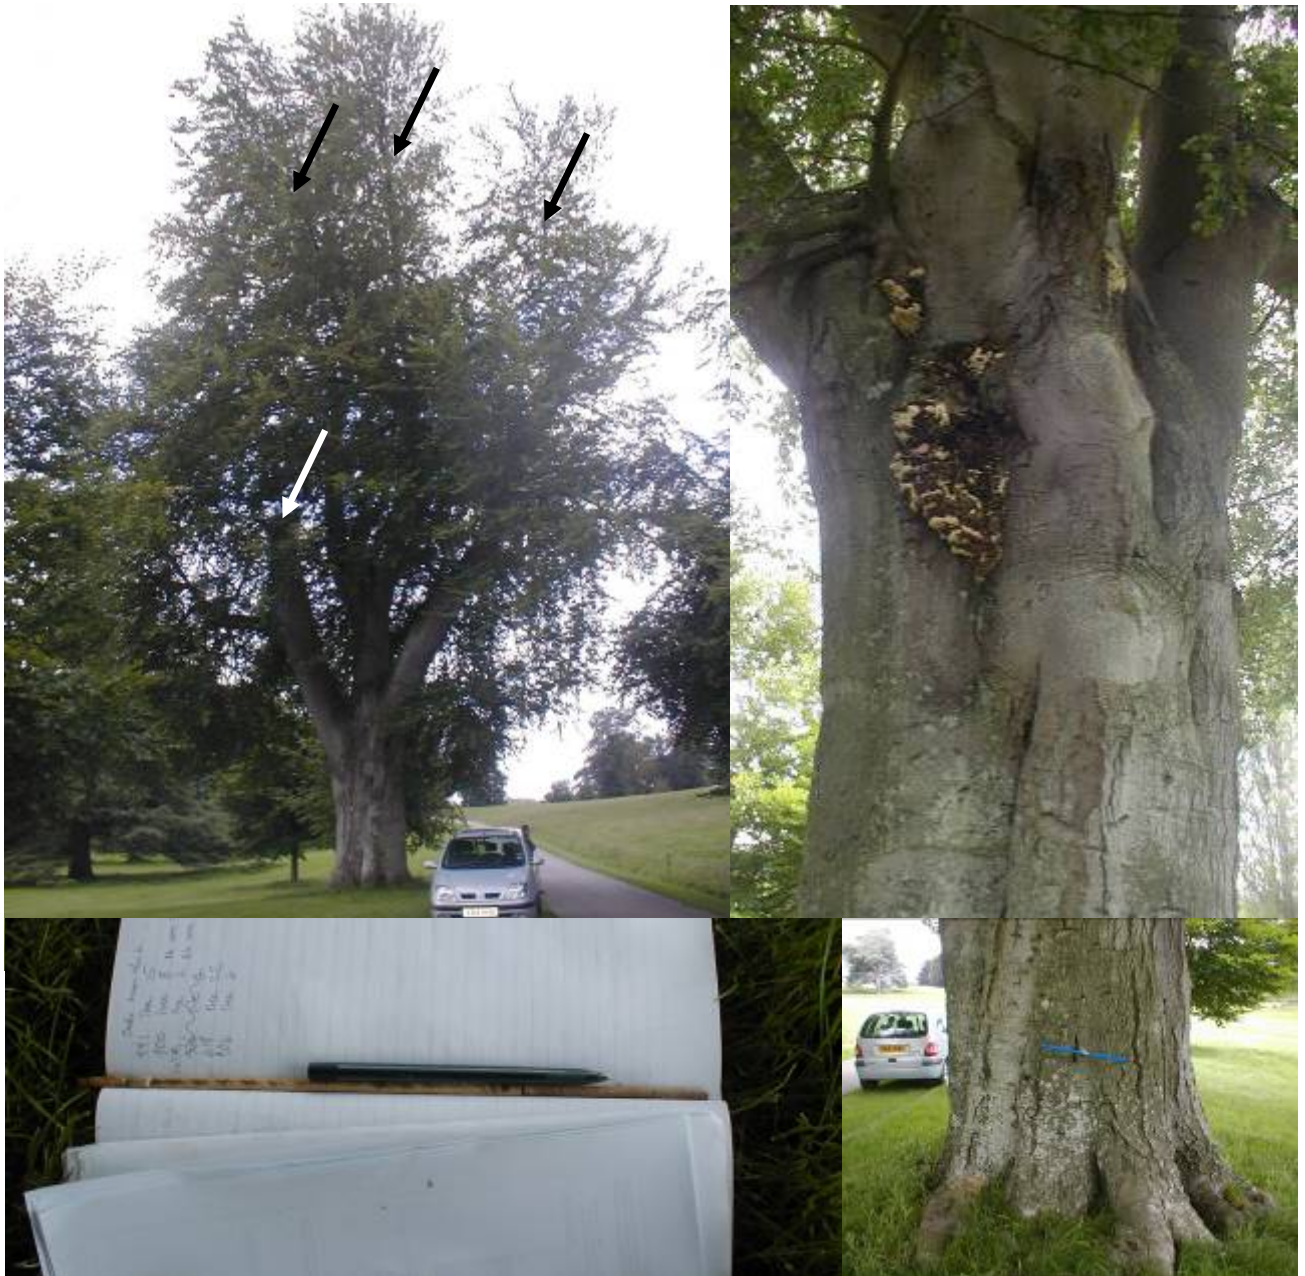
Tree 6 Outcomes.

The core taken where the radius of the tree is 63 cm shows 19.5 cm of sound wood with the tree having around 73% decayed tissue at the height. Fruiting bodies were present at several points on the main-stem. Tree 6 has already shed some major branches and has had some major reduction to a branch (white arrow) the functionality extending into the canopy indicates that the tree could withstand some moderate reduction and the tree could be further protected by reducing the height back to the points indicated by the black arrows. This would reduce the canopy below the surrounding trees and would be best done as smaller amounts over two or three growing seasons. Re-inspect in 12 months.

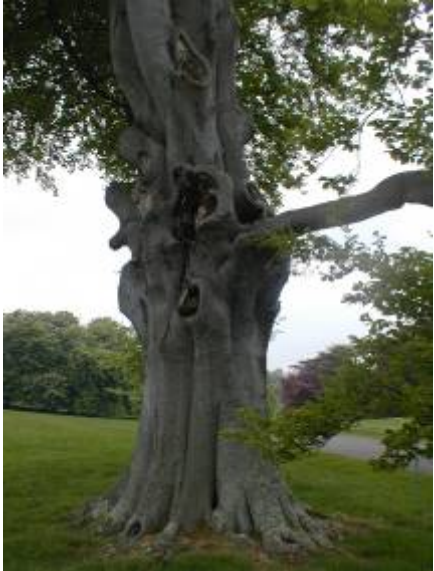
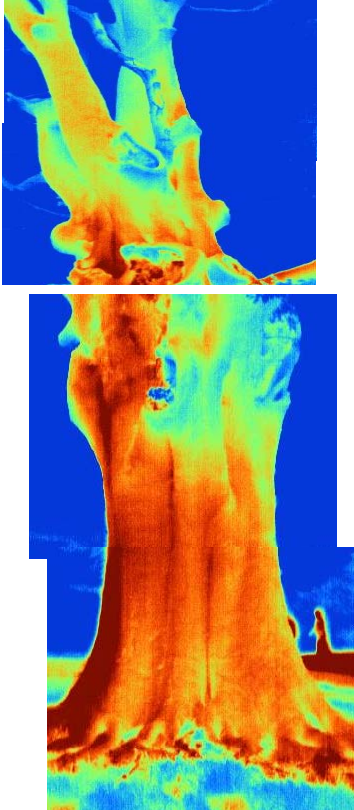
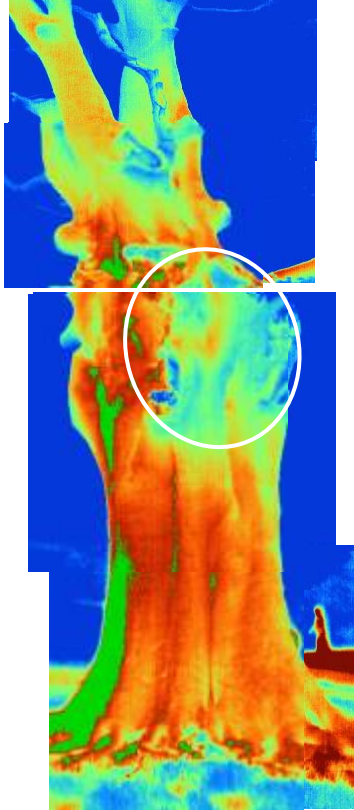
Visual Image	Thermal Image	Annotated Image	Annotation Details

<p>Data Sheet: Tree7-1 Date: 03/05/07 Client: Paul Orsi, Blenheim Palace Tree No.: 7 TAG No.: No Tag Species: <i>Fagus Sylvatica</i> Location: Near Tree 900 Position: Close to road Direction Images Taken: 13°</p>	<p>Summary of inspection details: The tree has substantial amounts of dead tissue close to the surface (green coloured areas) but there are also thicker volumes of functional wood (red-orange areas) that continue up the main-stem into the branches. Blue areas indicate open cavities from which heat is being lost. Fruiting bodies of <i>Ustulina deusta</i> and possibly <i>Ganoderma spp.</i> Are also present (see below). Outcomes: The tree has 70-80 dysfunction in the base that progresses up the main stem and into the branching points. There is a high probability of failure in the base, main-stem or branches. Although dysfunction is high, the functional wood extending into the branches gives possibilities for crown reduction to retain the tree.</p>

<p>The green coloured areas indicate superheated areas where dead wood is close to the surface. White circled area (blue-green) indicates where large volumes of dysfunctional wood are close to the surface extending from the wounds.</p>

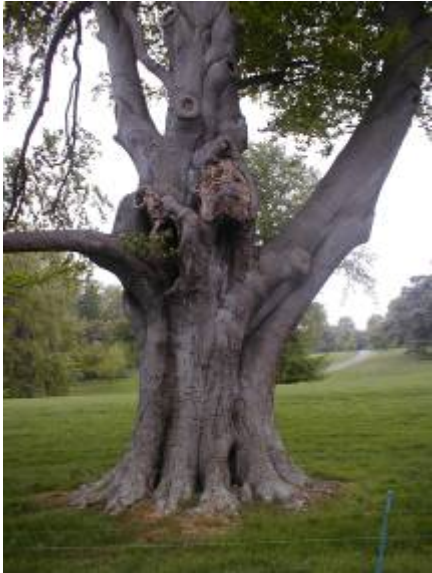
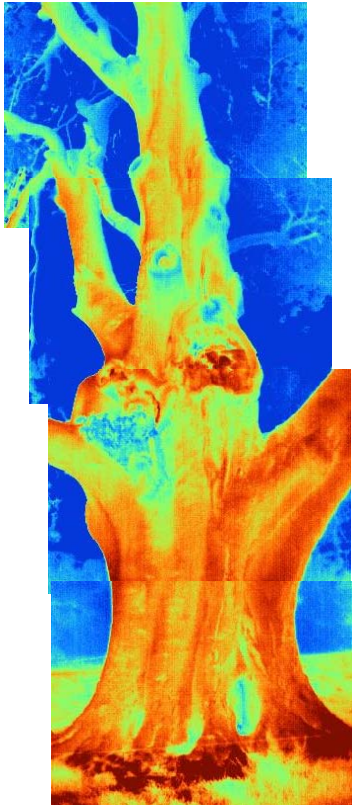
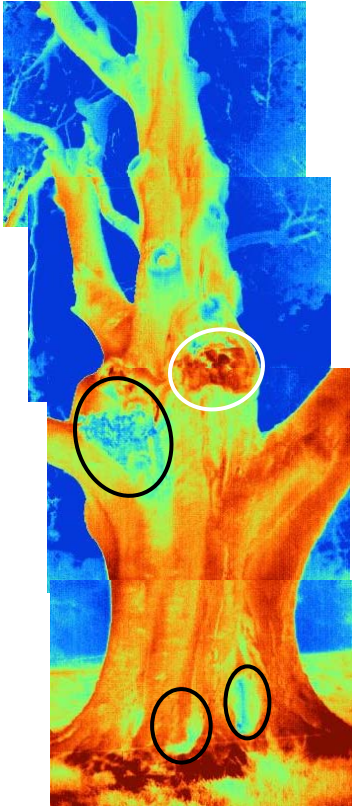
Visual Image	Thermal Image	Annotated Image	Annotation Details

Data Sheet: Tree7-2
Date: 03/05/07
Client: Paul Orsi, Blenheim Palace
Tree No.: 7
TAG No.: No Tag
Species: *Fagus Sylvatica*
Location: Near Tree 900
Position:
Direction Images Taken: 262°

Summary of inspection details:
 The tree has substantial amounts of dysfunctional solid wood (red areas). Blue areas indicate open cavities from which heat is being lost.
Outcomes:
 Refer to the previous sheet.

<p> Black circled areas (blue-green) indicate surfaces close to large cavities. White circled area (dark-red) indicates dead tissue. There are volumes of good functional wood in the main-stem and extending into the canopy (red-orange colours). </p>

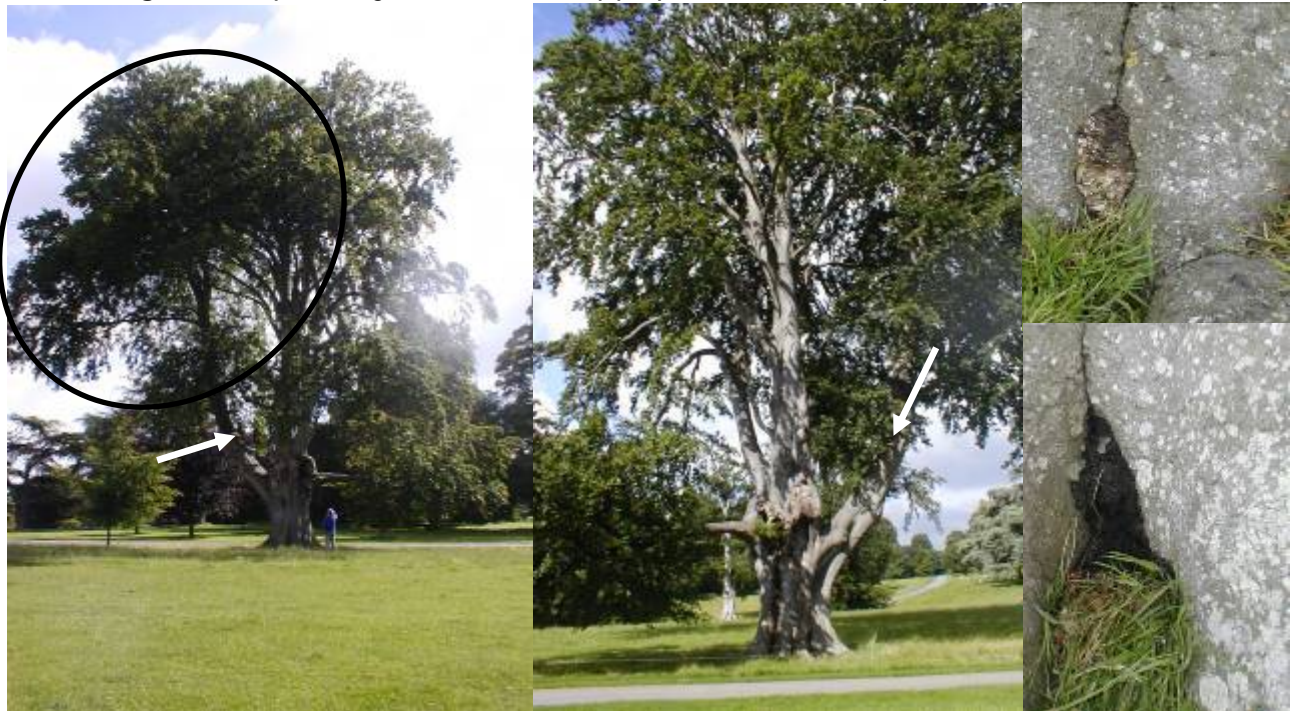
Tree 7 Outcomes.

Tree 7 has already been through a process of major branch shedding and most of the remaining branches appear functional and stable. They do however sit on a large area of complex dysfunctional wood which is likely to be an unstable volume that might be a point of failure in the future. In addition there is an over-weighted branch (white arrow in photographs). It is recommended that the canopy associated with this branch (circled black) is initially reduced in height and width so that the volume is reduced by $\frac{1}{4}$ followed by monitoring of re-growth and reduction by a further $\frac{1}{4}$ in two to three years time if it response well. The remainder of the canopy should be reduced to retain the overall appearance of the tree This would be best done as smaller amounts of crown management phased in over two or three growing seasons. *Ustulina deusta* and old fruiting bodies possibly *Ganoderma spp.* present. Re-inspect in 12 months.

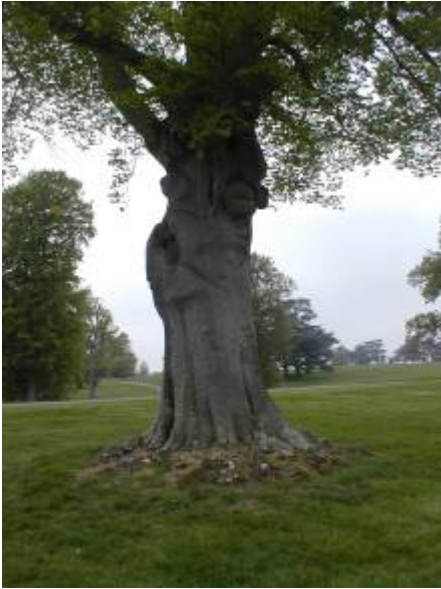
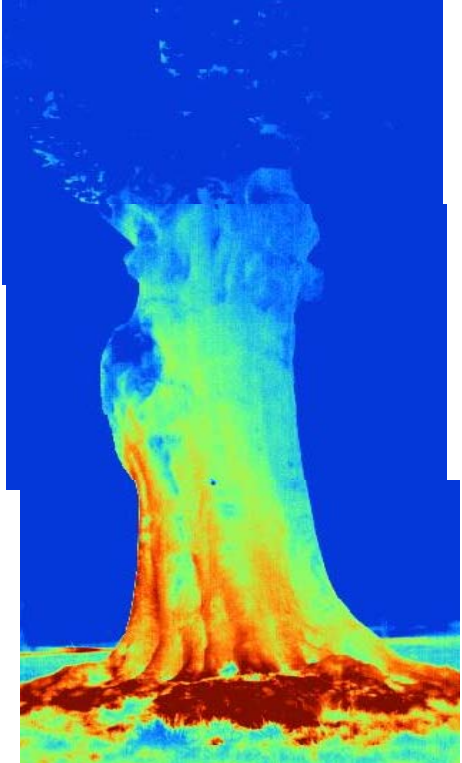
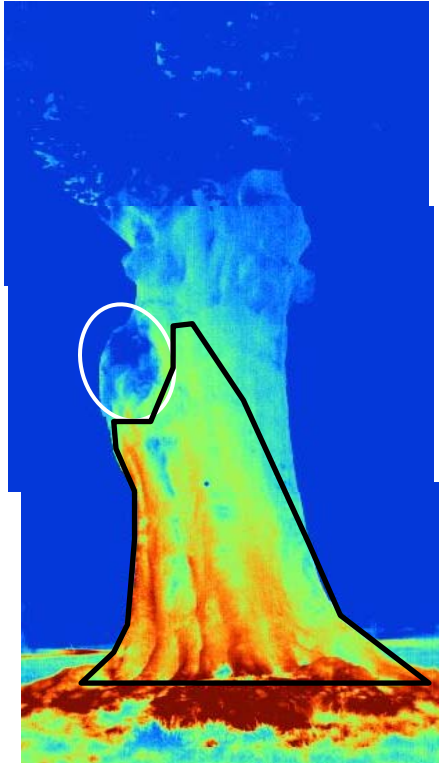
Visual Image	Thermal Image	Annotated Image	Annotation Details

<p>Data Sheet: Tree8-1 Date: 03/05/07 Client: Paul Orsi, Blenheim Palace Tree No.: 8 TAG No.: 900 Species: <i>Fagus Sylvatica</i> Location: GB > Fisheries first tree on RHS. Position: Few meters from road Direction Images Taken: 302°</p>	<p>Summary of inspection details: There is an area of good functionality at the base of the tree but this does not continue into the canopy where cooler blue colours are evident. There is a large open cavity at 17° with a large area of dead tissue close to the surface (coloured green) that is also apparent at 302° white circled area. Some fruiting bodies were also present (see appendices). Outcomes: The tree has 70-80 % dysfunction in the base that progresses up the main stem and into the branching points. There is a high probability of failure in the base, main-stem or branches. Although dysfunction and decay are high, the crown is naturally reducing and the tree can be retained followed by re-inspection in 12 months.</p>

<p>There is an area of good functionality (enclosed in black) indicated by the red-orange colours. However this does not continue further up the canopy where cooler blue colours are evident. The white circled area (blue) indicates a large cavity.</p>

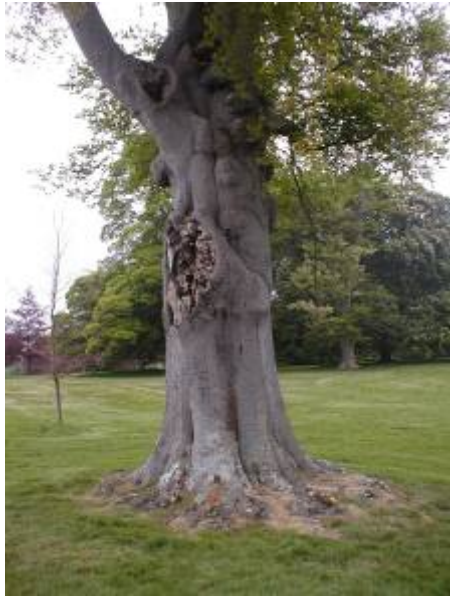
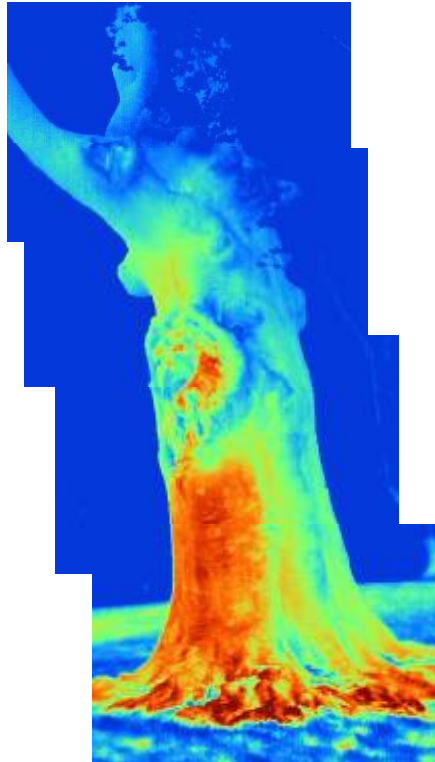
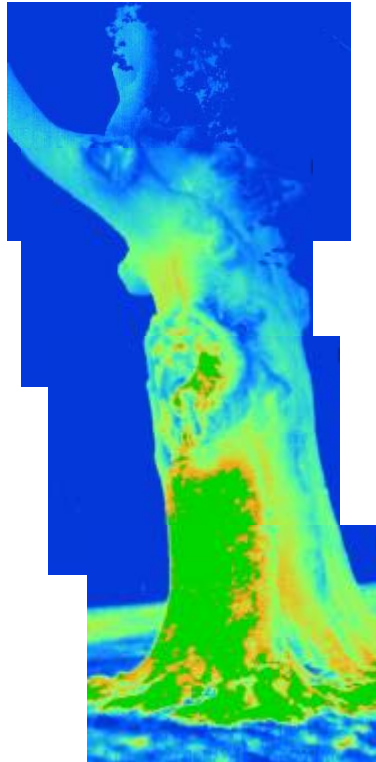
Visual Image	Thermal Image	Annotated Image	Annotation Details

Data Sheet: Tree8-2
Date: 03/05/07
Client: Paul Orsi, Blenheim Palace
Tree No.: 8
TAG No.: 900
Species: *Fagus Sylvatica*
Location: GB > Fisheries first tree on RHS.
Position:
Direction Images Taken: 17°

Summary of inspection details:
 There is a substantial superheat area indicating decayed bark. Temperature inversion is present with cooler areas in the lower stem indicating healthier tissues. There area areas of cooling associated with venting from open cavities.
Outcomes:
 Refer to the previous sheet.

<p>Green coloured area indicates large area of decay close to the surface (superheated area) indicating a probable large cavity extending from the opening apparent in the photograph. Behind this are orange colours indicating strong area of functional tissue probably reactive growth.</p>

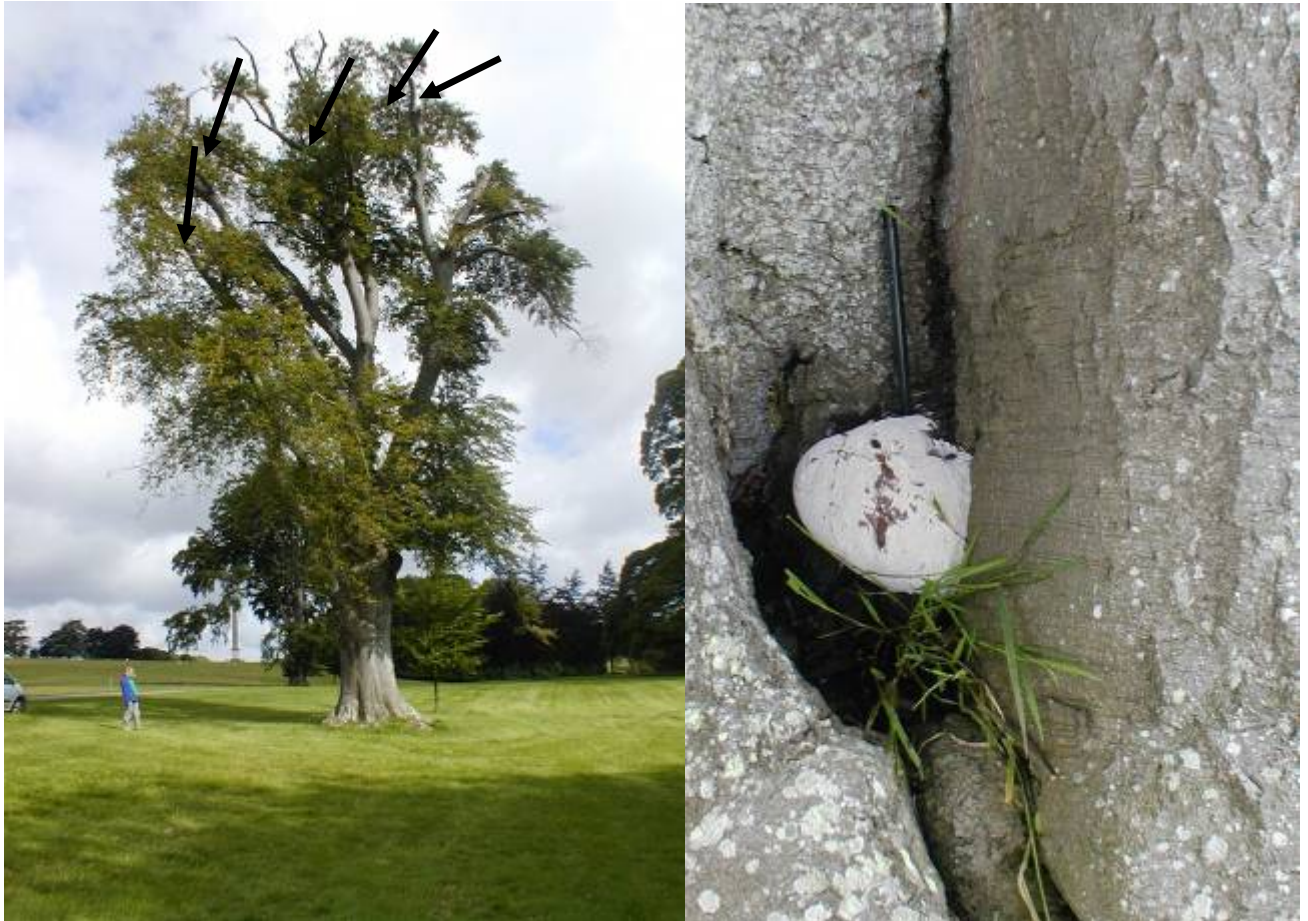
Outcomes Tree 8.

Tree 8 is already in a state of natural decline caused by the restricted functionality from the main-stem into the canopy. This is reducing the canopy back to points indicated by the black arrows. Therefore the tree is naturally reducing the wind pressure on the canopy and crown management should be phased in over two or three growing seasons to remove dead wood. Fruiting bodies present possibly *Ganoderma spp.* Further monitoring of decline will help with this process. Re-inspect in 12 months.

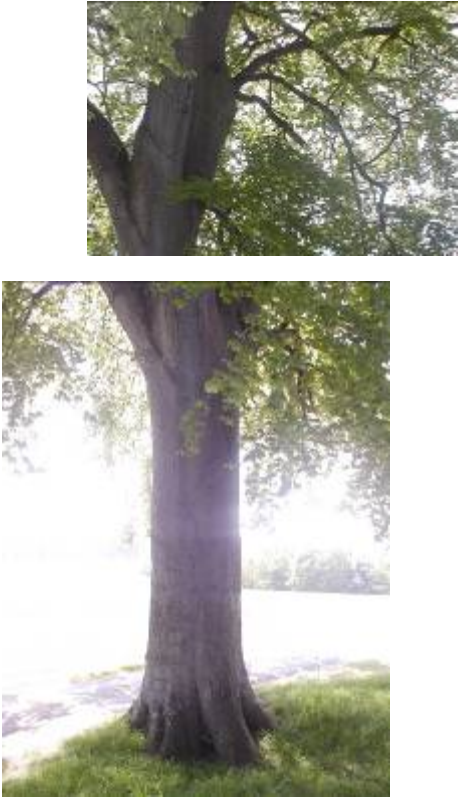
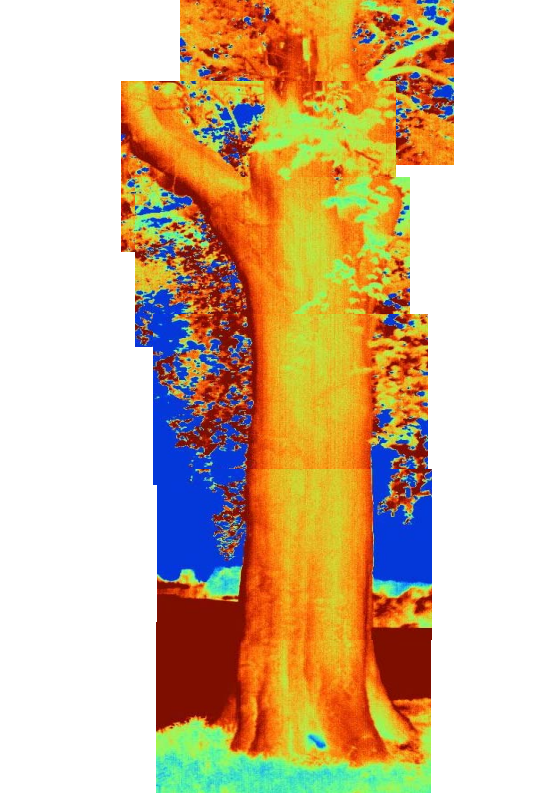
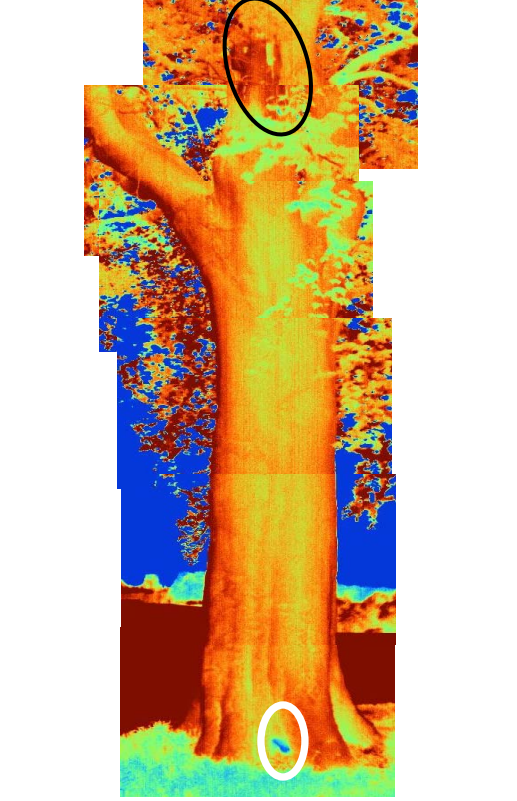
<p>Data Sheet: Tree14 Date: 03/05/07 Client: Paul Orsi, Blenheim Palace Tree No.: 14 TAG No.: 521 Species: <i>Fagus sylvatica</i> Location: China Corner next to lightning struck cedar. Position: Close to road and perimeter wall. Direction Images Taken: 220°</p>		<p>Summary of inspection details: The tree has a column of decay throughout the main-stem; this is not at a critical stage. However, there is an area advanced decay above the first branch (circled dark-red area). Outcomes: There is only 30-40% dysfunction in the main-stem and there is only a moderate probability of base or stem failure, however, the decay in the branching points is a high probability and weight above this point must be reduced by 1/3 over two growing seasons followed by re-inspection in every 12 months.</p>	
Visual Image	Thermal Image	Annotated Image	Annotation Details

<p>Whit circled area (blue) indicates presence of <i>Ganoderma spp</i> fruiting body. Black circled area (dark-red) indicates larger area of dead wood.</p>

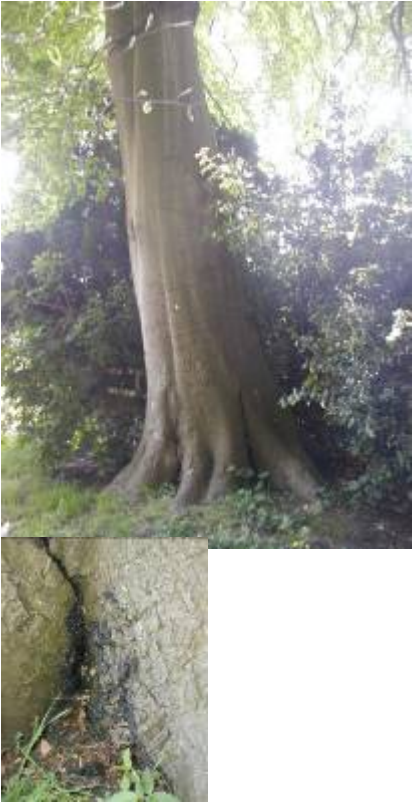
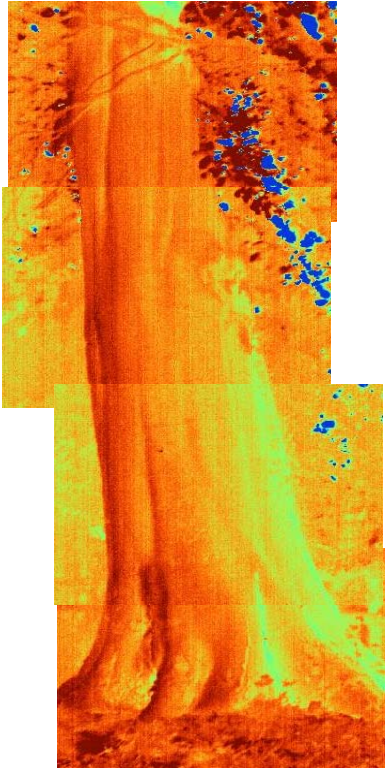
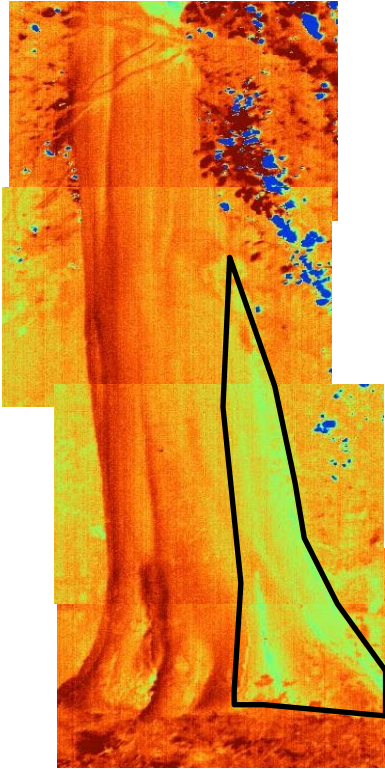
<p>Data Sheet: Tree 15 Date: 03/05/07 Client: Paul Orsi, Blenheim Palace Tree No.: 15 TAG No.: 941 Species: <i>Fagus sylvatica</i> Location: Hensington Clump next to CC football pitch. Position: Close to perimeter wall and neighbouring property Direction Images Taken: 220°</p>		<p>Summary of inspection details: Dysfunctional wood is restricted to the back half of the tree. Outcomes: There is 40-50% dysfunction in the base of the tree, However the tree has a lean of around 20° from vertical and the decay is predominantly in the back half of the tree. The tree is a high probability of failure. <i>Ustulina deusta</i> is present and an invasive inspection should be carried out.</p>	
Visual Image	Thermal Image	Annotated Image	Annotation Details

<p>Black enclosed area indicate a volume of thin functional wood over a large volume of dysfunctional wood at the back of the tree. The front half of the tree contains a large volume of functional wood shown by the warmer surface (red-orange colours)</p>

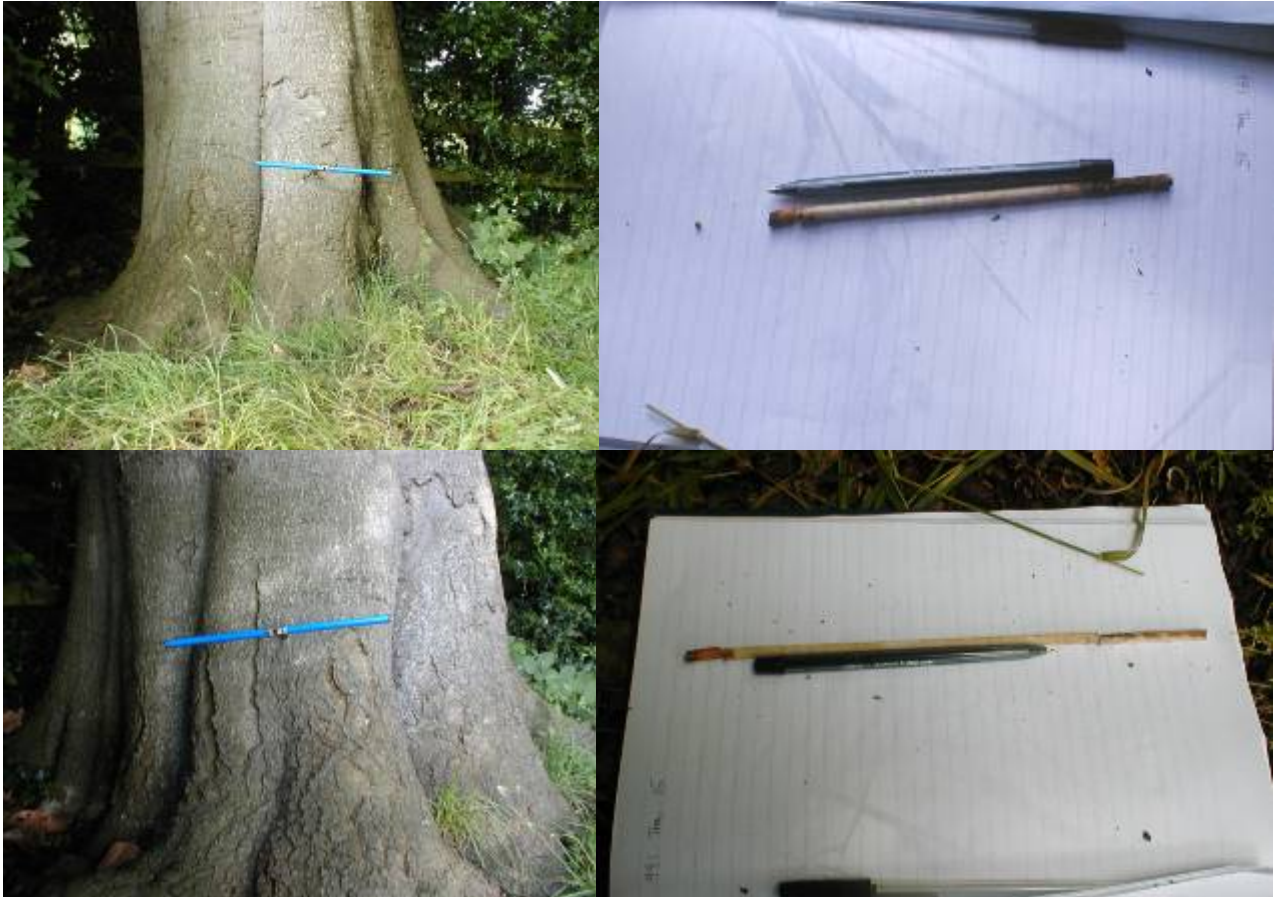
Follow-on Invasive Inspection: Tree 15.

The radius of the base of the tree at the height where cores were taken from was 47cm. Cores taken from the more dysfunction part of the tree shown in the thermal images above (top photographs) had decay at 12 cm and the more functional part of the base had decay at 22 cm (bottom photographs).

Following the invasive inspection it was determined that the tree was around 43% decayed at the base and was a high probability of failure given the position of the decay in relation to the lean of the tree. Therefore the canopy would require reduction in height by a third to bring about stability, this was not thought to be feasible given the canopy structure of the tree and so felling was recommended.

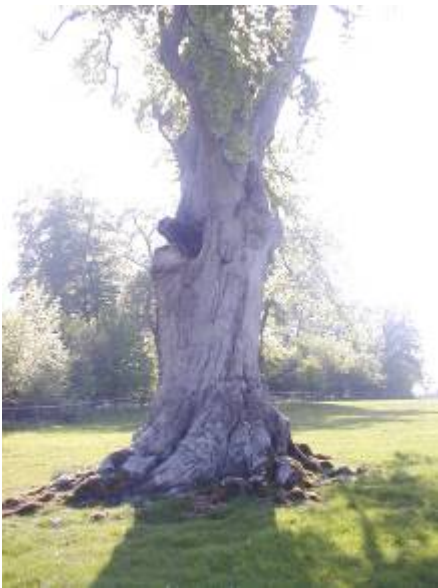
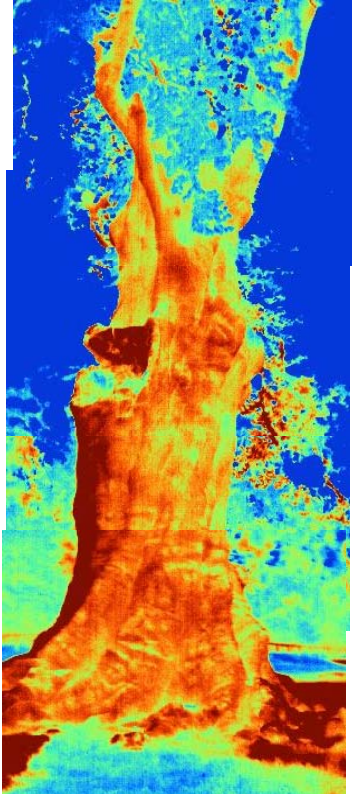
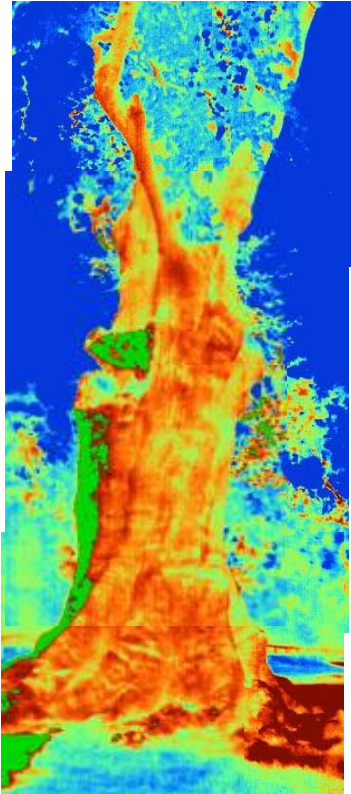
Visual Image	Thermal Image	Annotated Image	Annotation Details

<p>Data Sheet: Tree 20 Date: 03/05/07 Client: Paul Orsi, Blenheim Palace Tree No.: 20 TAG No.: 620 Species: <i>Fagus sylvatica</i> Location: PF > GB RHS near cinder track. Position: Close to walking track some meters from road Direction Images Taken: 259°</p>	<p>Summary of inspection details: There are areas of superheating indicating areas where dead wood is close to the surface. Most of the main-stem shows good healthy growth though there is a central area of dysfunction. The client identified <i>Meripilus giganteus</i>. Outcomes: The tree has 50-60% dysfunction in the base that progresses up the main stem and into the branching points. The thin crown of the tree means it is a moderate probability of failure in the base, main-stem or branches. The crown will require some reduction to retain it if the dysfunction continues. An invasive inspection of the roots is recommended followed by re-inspection with thermal imaging on an annual basis.</p>

<p>Green coloured areas marked indicate areas where dead wood is close to the surface.</p>

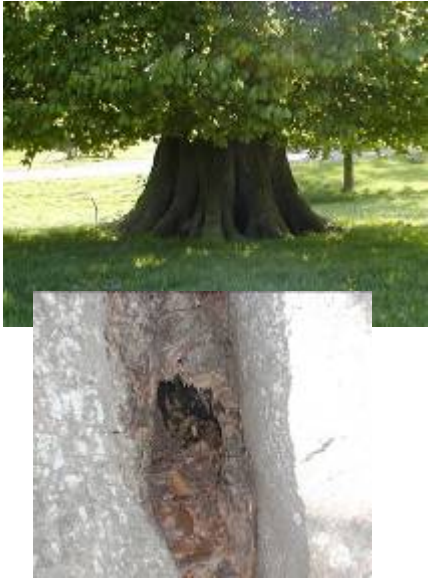
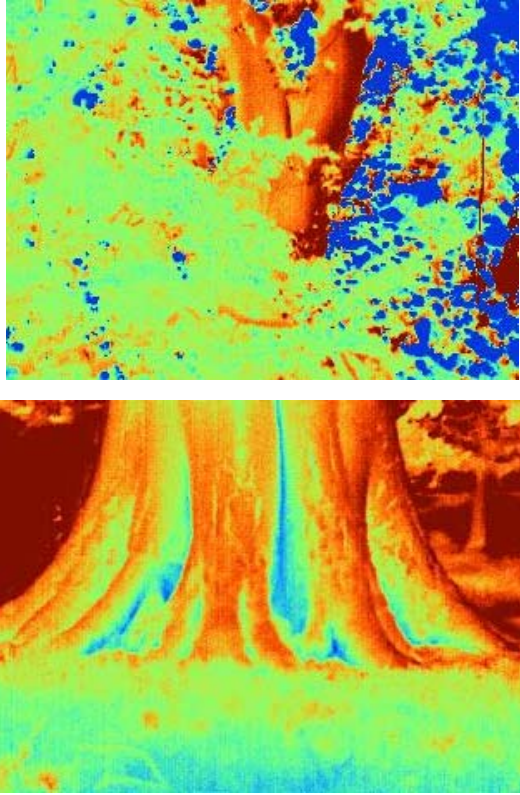
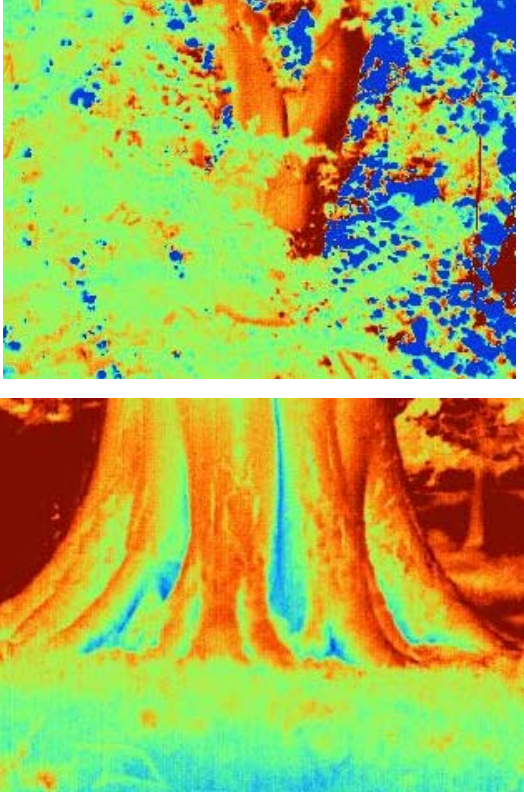
Visual Image	Thermal Image	Annotated Image	Annotation Details

<p>Data Sheet: Tree 21 Date: 03/05/07 Client: Paul Orsi, Blenheim Palace Tree No.: 21 TAG No.: 621 Species: <i>Fagus sylvatica</i> Location: PF > GB LHS opposite 620. Position: Some meters from road Direction Images Taken: 236°</p>	<p>Summary of inspection details: Red colours show healthy buttresses, blue colours between indicate central decay caused in part by <i>Ustulina deusta</i> (see inset photo)</p> <p>Outcomes: The tree is 60-70% dysfunctional at the base and it is a high probably of failure in its present state. The tree has a dense differentiated canopy and the tree can be retained long-term if a programme of gradual canopy reduction is instigated now followed by regular re-inspection on an annual basis.</p>
---	---

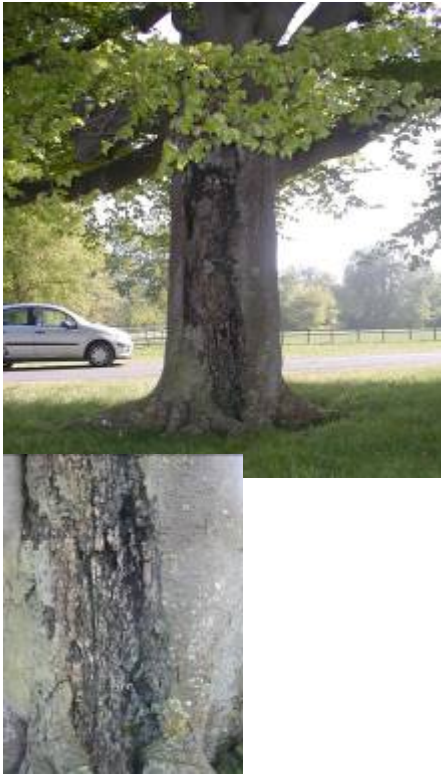
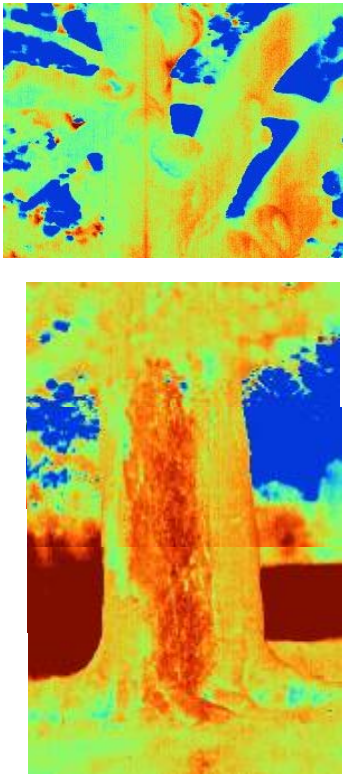
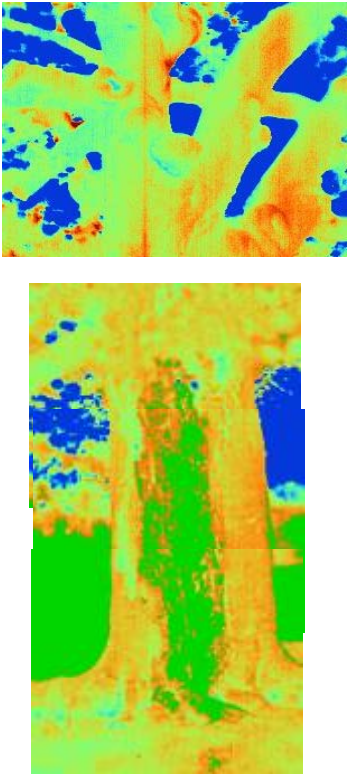
Visual Image	Thermal Image	Annotated Image	Annotation Details

<p>Data Sheet: Tree 22 Date: 03/05/07 Client: Paul Orsi, Blenheim Palace Tree No.: 22 TAG No.: 618 Species: <i>Fagus sylvatica</i> Location: PF > GB squat beech on LHS. Position: Close to road Direction Images Taken: 190°</p>	<p>Summary of inspection details: There is a substantial area of decay with <i>Ustulia deusta</i> fruiting bodies present. It is highly probable the decay extends into the root system. Outcomes: The base of the tree is 80-90% dysfunctional but is only a high probability of failure because of its low canopy. An invasive inspection is recommended since the tree has a very low canopy and might be retained if there is sufficient sound wood.</p>
---	---

<p>Green coloured area indicates superheated area due to substantial decay.</p>

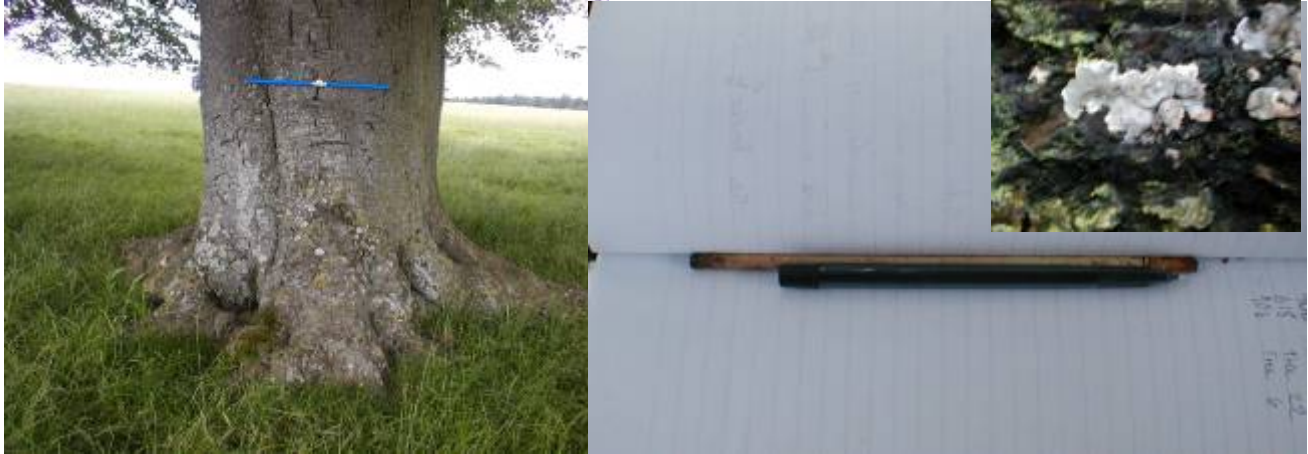
Outcomes Tree 22.

Core taken from healthy side of tree where the radius of the tree is 39 cm at this height showing 15 cm of sound wood. Showing around 83% decay. Inset, fruiting bodies of *Ustulina deusta*. Re-inspect in 12 months.
