Arborist Report

6 Mary Street
Birkdale
Redland City, Qld

Client
Tershan Pty Ltd
On Behalf of Project Services
GPO Box 2906
Brisbane Qld 4001

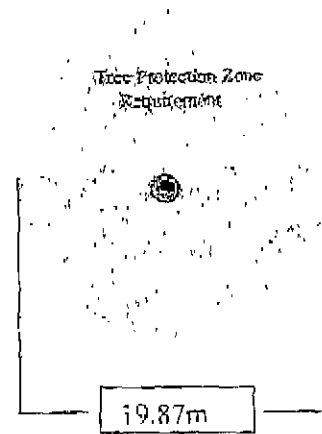
Tree # 1

Deadwood < 1% & < 50mm pieces, no hangers within crown.

95% leaf density. Past pruning indicates tree has been pruned for utility services with some limb stubs not correctly collar cut. No signs of limb drop except that of naturally shedding smaller limbs. Some tight rubbing limbs. Minimal organic layer around base, leaf litter only. Tight codominant leaders of similar diameter from base with a 2 metre long area of included bark. Full weeping canopy displaying good vitality and mostly even shoot extension throughout the crown. Good open limb unions throughout the tree, some tight rubbing limbs.

S.U.L.E. : at the time of assessment this tree has a Safe Useful Life Expectancy of more than 10 years.

This tree is 800mm outside boundary fence and the truncated area that is lost due to the retaining wall represents 20.3% of the Tree Protection Area. No encroachment to the Critical Root Zone will occur. There are extended areas on both sides of the tree that will be suitable for offsetting this compromised area.

Canopy clean and remove rubbing limbs. Tree Protection guidelines implemented. Mulching. See details in General Conditions. This tree will need an Arborist review again in 2 years.

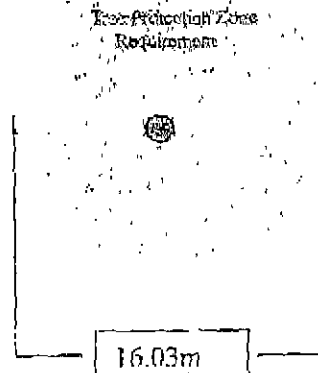
Tree # 2

Deadwood < 1% & < 50mm pieces, no hangers within crown.

95% leaf density. No past tree work visible. No signs of limb drop except that of naturally shedding smaller limbs. Minimal organic layer around base, leaf litter only. Lower trunk and buttress area displaying no visual faults. Single clean, even trunk with good taper. Canopy exhibits vitality although the crown shape has been effected by crowding. Even shoot extension throughout canopy. Good open limb unions throughout the tree.

S.U.L.E. : at the time of assessment this tree has a Safe Useful Life Expectancy of more than 20 years.

This tree is 450mm outside boundary fence and the truncated area that is lost due to the retaining wall represents 16.6% of the Tree Protection Area. No encroachment to the Critical Root Zone will occur. There are extended areas on both sides of the tree that will be suitable for offsetting this compromised area.

Canopy clean and remove rubbing limbs. One lateral limb to be removed that will interfere with new building line. Tree Protection guidelines implemented. Mulching. See details in General Conditions. This tree will need an Arbotist review again in 2 years

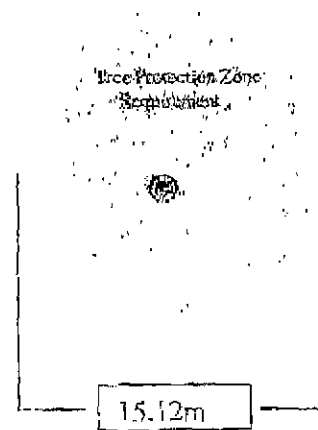
Tree # 4

Deadwood > 2 % of the canopy is deadwood of different sizes no hangers within crown.

90% leaf density. No signs of limb drop except that of naturally shedding smaller limbs. Minimal organic layer around base, leaf litter only. Lower trunk and buttress area displaying no visual faults. Old termite nest at base. Single clean, even trunk with good taper. Canopy exhibits vitality with the shape effected by crowding resulting in distorted lateral growth within crown. Good open limb unions throughout the tree. Old termite nest within lower fork of tree.

S.U.L.E. : at the time of assessment this tree has a Safe Useful Life Expectancy of more than 20 years.

This tree is 730mm-750mm outside boundary fence and the truncated area that is lost due to the retaining wall represents less than 12.0% of the Tree Protection Area. This could be less depending on the end of the wall. No encroachment to the Critical Root Zone will occur. There are extended areas on both sides of the tree that will be suitable for offsetting this compromised area.

Canopy clean. One lateral limb to be removed that will interfere with new building line. Tree Protection guidelines implemented. Mulching. See details in General Conditions.

This tree will need an Arborist review again in 2 years
