Extraordinary Council Meeting Tuesday 14 September 2010

- 1 [GM-ECM] Arborist Report - White Fig Tree located in the carpark of the Chinderah Tavern known as Lot 2 DP 781464, Nos. 156-160 Chinderah Bay Drive, Chinderah

RE: Tree Risk Assessment; White Fig, Chinderah Tavern

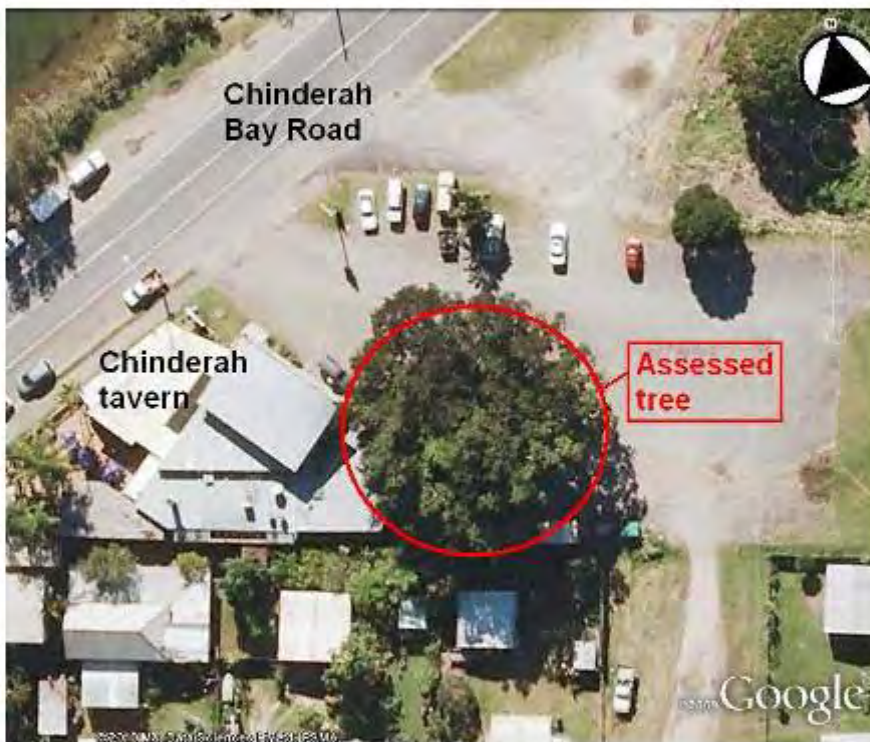
Picture 1: Location of the assessed tree

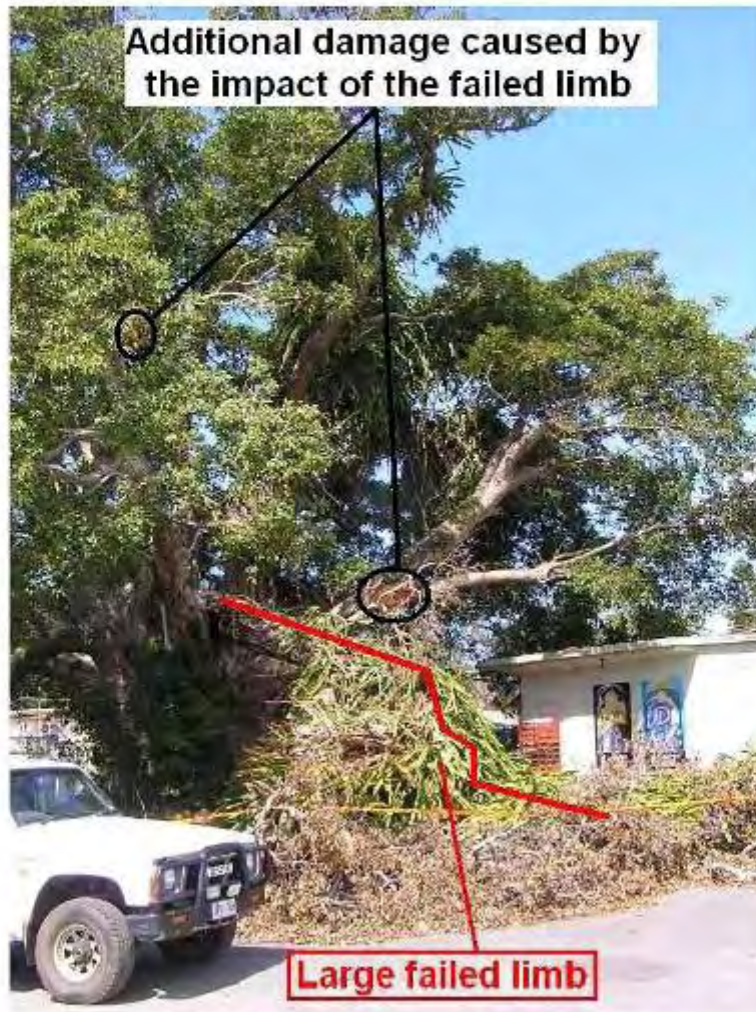
A large diameter limb (>450mm) on the northwest of the canopy very heavily laden with a large volume of the climbing cactus *Hylocereus sp* had recently failed, tearing out two smaller branches beneath it as it fell.

Picture 2: Failed limb northwest side of the fig tree

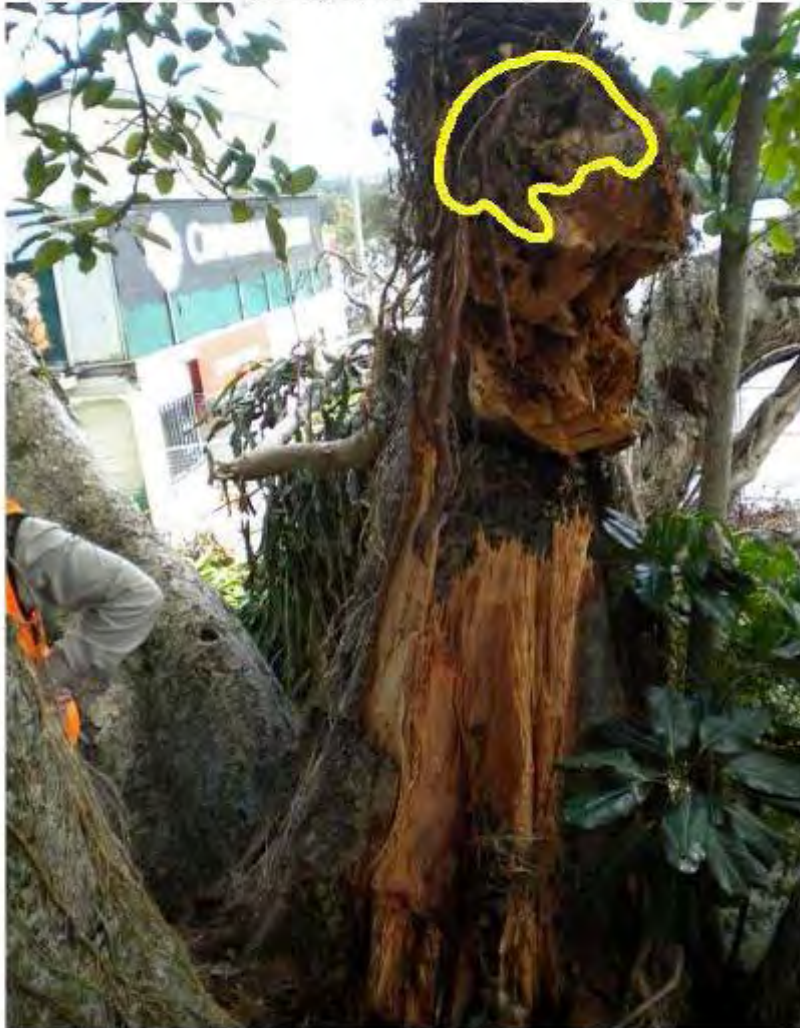
In failing the large limb pivoted over another scaffold limb directly beneath it, this has exposed the torn cross-section through the base of the failed limb and revealed wood decay (white pocket rot) through what was the tension side of the limb.

Area of wood decay indicated by discolouration

Picture 3: Failed limb pivoted on limb below wood decay

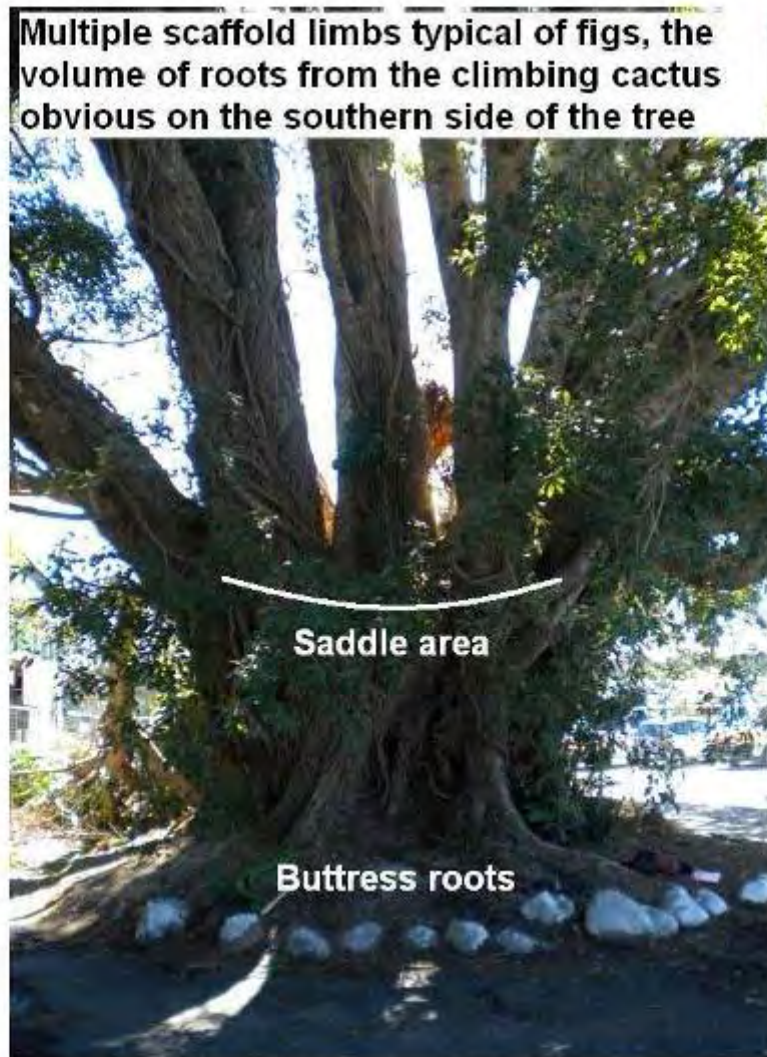
Typical of figs of this age the main stem of the tree is comprised of the union of numerous coalesced scaffold limbs. The saddle where these limbs originate has over time been filled with detritus made up of decaying leaves, bark and small diameter deadwood. The proliferation of climbing cactus roots in this rich growing medium have formed a very dense matt through the saddle area.

Picture 4. Form of the main stem and scaffolds typical of fig trees

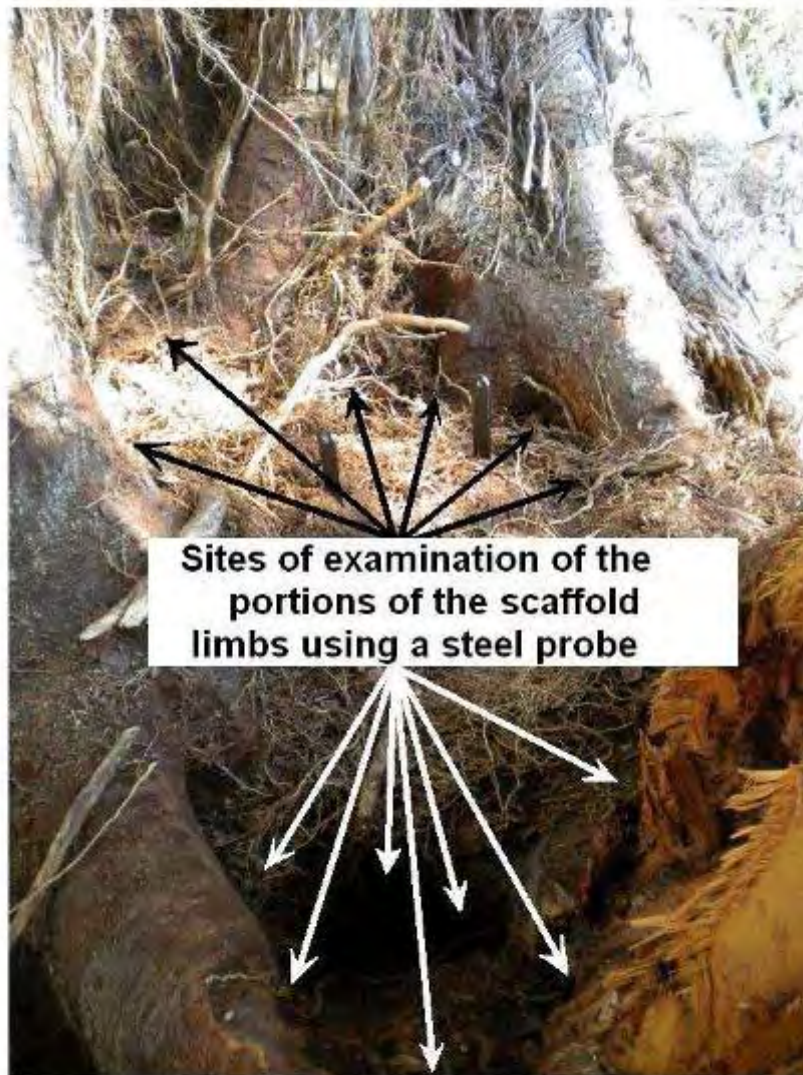
Manual removal of cactus roots and excavation of detritus matter from the saddle area permitted an inspection and the physical probing of the bark surfaces of the scaffold limbs forming the saddle area.

Figure 5: External surfaces of the scaffold limbs physically examined using a steel probe

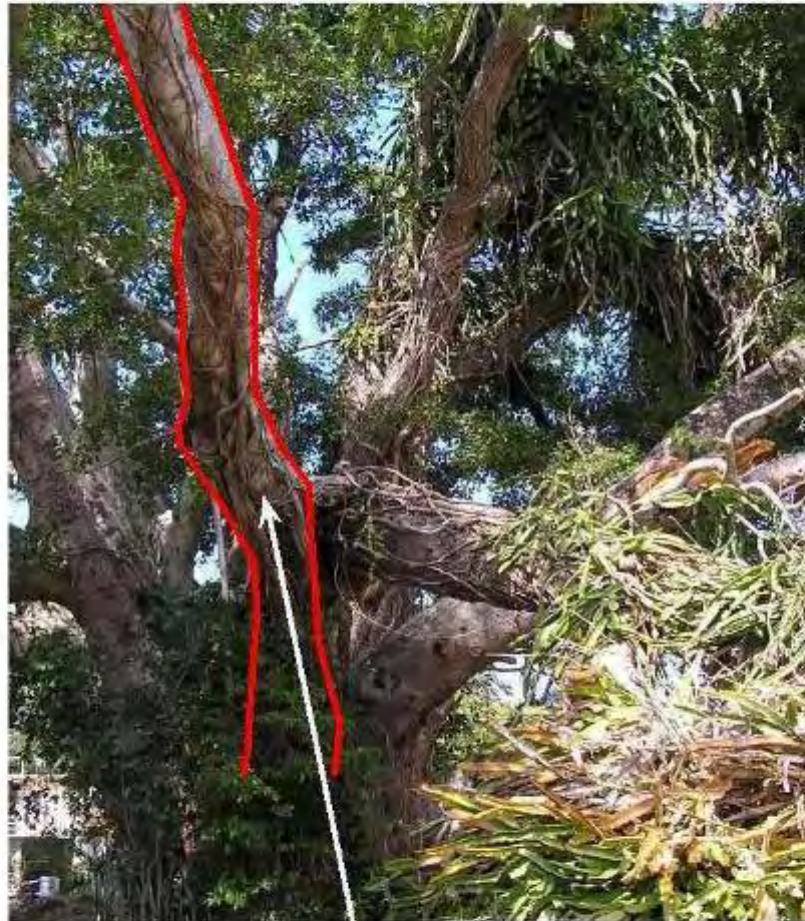
Results of the physical examination using the steel probe indicated that the decay column exposed by the recent overloading of the large limb extends into the lower limb on which it pivoted during the failure event. All other areas tested on the other scaffold limbs did not permit the steel probe to penetrate further than the bark cambium.

Scaffold limb with significant volume of decay on the tension side indicated by the penetration of the steel probe

Picture 6: Lower scaffold limb (under the recent failed limb) with decay on the tension side of the limb

- o The lower scaffold limb on which the failed limb has pivoted and is currently resting was found to have extensive wood decay through the upper tension side of the limb
- o Due to the pronounced elongated and sparse form of this limb we do not consider reduction pruning an effective option in this instance.

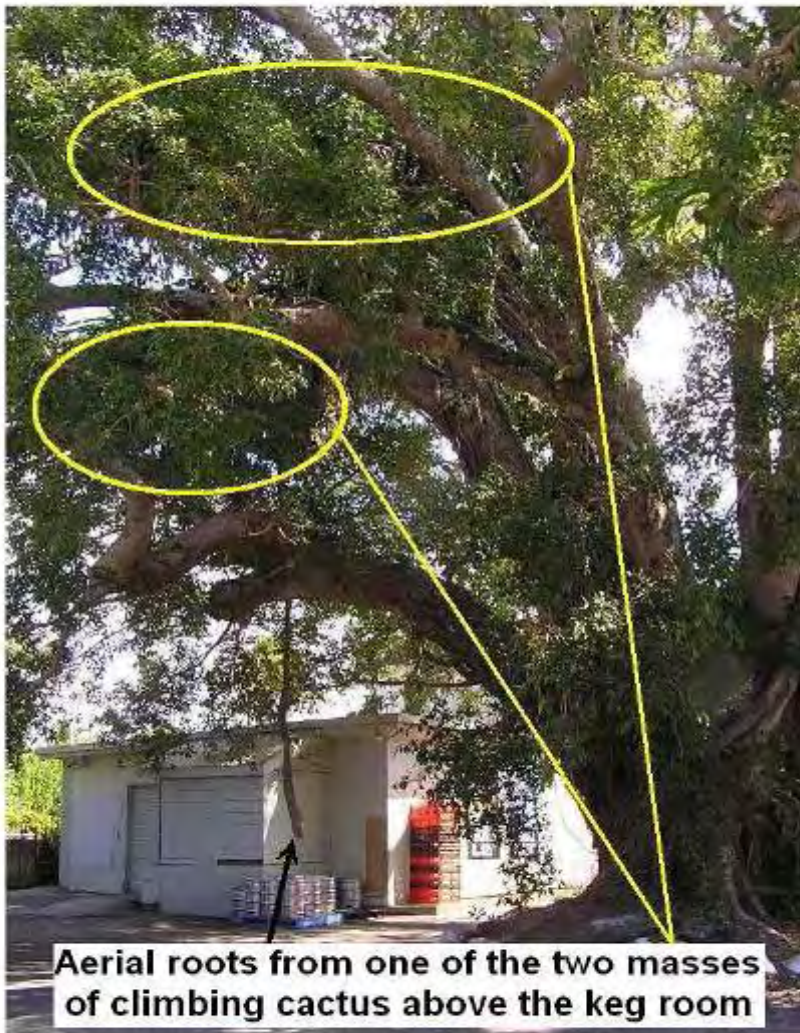
During an aerial inspection (using EWP) very large volumes of climbing cactus *Hylocereus sp* were observed on two scaffold limbs growing on the southern side of the tree, above the keg room of the tavern. The density of cactus growth had suppressed normal foliage growth in these affected portions of the fig tree.

Picture 7: Two masses of climbing cactus above the keg room
