Arborist Report

6 Mary Street
Birkdale
Redland City, Qld

Client
Tershan Pty Ltd
On Behalf of Project Services
GPO Box 2906
Brisbane Qld 4001

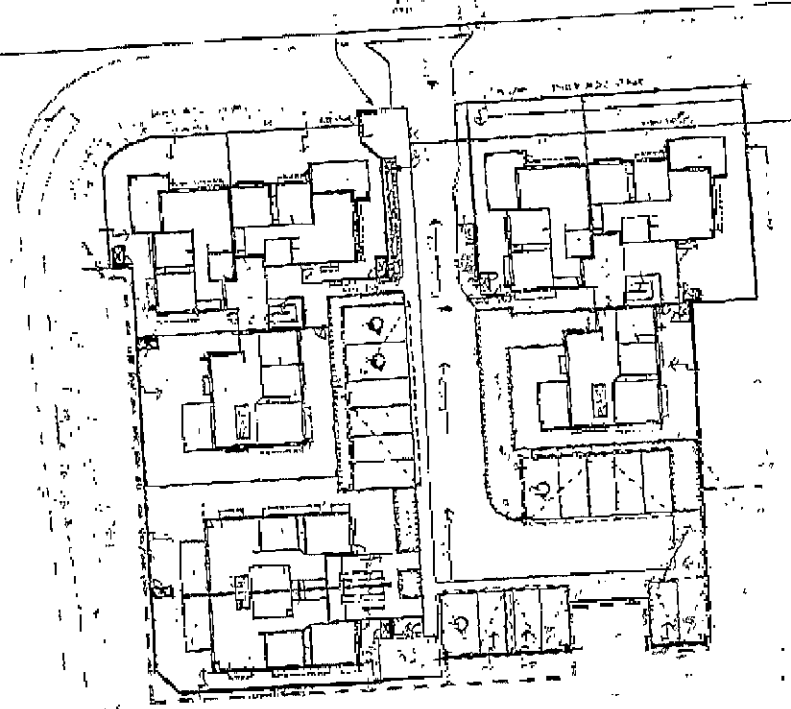
SITE PLAN

EXISTING
 PLANTING
 TO BE MAINTAINED
 IN THE
 PROPOSED
 SITE

Tree Protection Fence
 Pending and Tree Protection Zones to be finalized
 after finalizing set out
